# An Experimental Investigation on the Causes of Flexible Pavement Failures: A Case Study on Tarcha - Yalo Road Section

Hailemichael Debalke Damota<sup>\*</sup>, Abel Tesfaye, Anteneh Geremew

Highway Engineering, Civil and Environmental Engineering, Jimma University, Jimma, Ethiopia

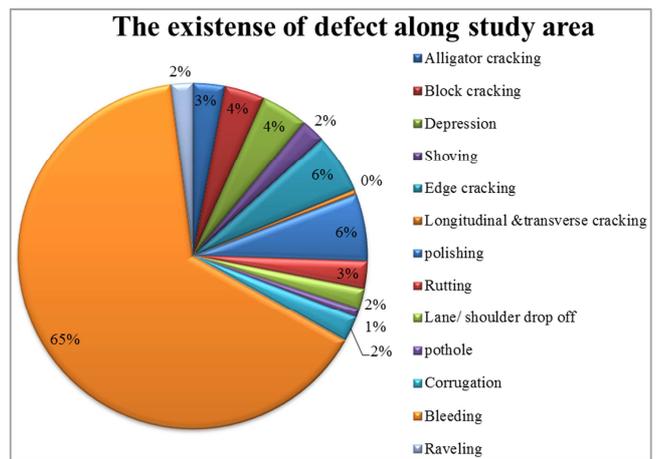
**Figure 3.** Pavement distresses distribution percentage.

The condition survey of the selected road segment was subdivided into five sections of road segments. The sections of segments Tarcha-Turi (19%), Waka-Tulema (24%), Tulema-Gesa (19%), Gesa-Ellabacho (16%) and Ellabacho-Yalo (22%). The survey was carried along the five subdivided sections and different types of flexible pavement distresses were viewed and observed. Distresses observed along the sections were alligator cracking, block cracking, depression, shoving, corrugation, polishing, edge cracking, edge drop off, rutting, raveling, transverse and longitudinal cracking, potholes and bleeding. Among the observed distresses Alligator cracking, potholes, bleeding, edge cracking, rutting and raveling were majorly dominant whereas depression, block cracking, shoving and polishing were moderately dominant and transvers and longitudinal cracking, edge drop off and corrugation were the least dominant.

According to the findings of the results from pavement distresses the dominant failures were structural and material failures. The structural failures were subjected to traffic load because the thickness of the pavement structures obtained in the field are not enough to withstand the traffic loads and the material factors were subjected to constructions condition and laboratory result influences because the compaction and material quality of sub grade and base course in failed section are not satisfied the ERA and AASHTO specifications. The construction was in progress of construction and the distresses were premature which implies the structural and environmental related problems should be the best concern and are the causes for failures.

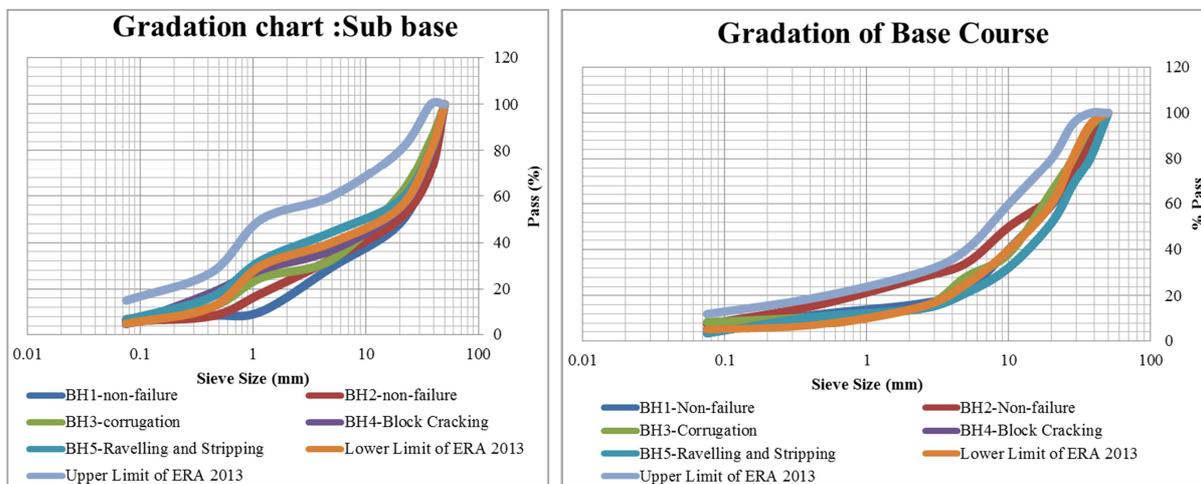
Figure 4. Gradation curve of Sub Grade, Sub Base and Base Course.

Comparing the laboratory test results for gradation with that of the specification for Base, and sub base materials and to determine the percentage of gravel and sand from grain size curve depending on percentage of fines (fraction smaller than 75micron sieve size) coarse grained soils are classified as follows: less than 5%: GW, GP, SW and SP. And more than 12%: GM, GC, SM, and SC. 5%-12% border line case required use of dual symbols. According to Unified soil classification system:-

- 1) In case of base course materials  $C_u = 55.1$ , which is greater than 4 shows a wide variation of size particles.  $C_c = 5.60$ , indicates well graded sand particles, According to USCS, base material is classified as well graded sand with gravel.
- 2) For the sub-base materials  $C_u = 50.78$ , which is greater than 4 shows a wide variation of size particles,  $C_c = 2.04$ , indicates well graded gravel particles. According to USCS, the sub base material is well graded gravel with sand.
- 3) The subgrade materials are classified as A-2-7, A-4 and A-5 according to AASHTO soil classification system.

Based on to Ethiopian road authority manual 2013, pavement design manual conventional aggregate was classified as graded crushed stone (GB1) and the grading limit of this material for 37.5mm nominal maximum aggregate size was used. As it was observed from the result Figure 3 above, RAPA contains a higher courser than that of a crushed natural aggregate compared to GB1 base course material standard depending on the milling and stockpiling operation. The result recorded above also above shows the ceramic waste aggregates fall within the limit. Generally, the Table 2 and Figure 3 reveal that the gradation results of CSA, RAPA and CWA were between upper and lower limits and

recommended to use as GB1 according to ERA specification. So, the gradation was accepted and suitable for the pavement construction materials.
