# Assess the Impacts of Environmental Factors (Temperature and Moisture) on the Performance of Flexible Pavement: A Case of Tarcha-OMO River Highway

Kebede Haile Folla, Gutema Wakjira Gemedo, Garuma Negasa Takuma. Assess the Impacts of Environmental Factors (Temperature and Moisture) on the Performance of Flexible Pavement: A Case of Tarcha-OMO River Highway. *American Journal of Civil Engineering*. Vol. 10, No. 4, 2022, pp. 162-174. doi: 10.11648/j.ajce.20221004.13

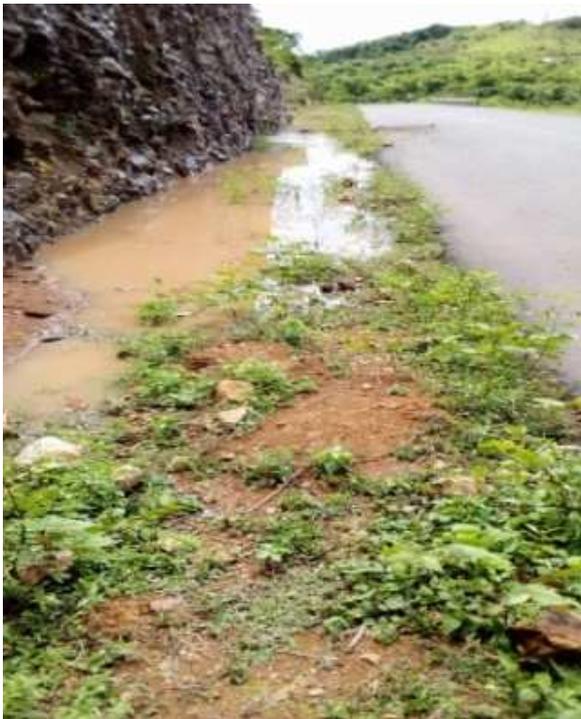
Figure 2. Site observation (photo: by Kebede Haile, 21th May, 2021).

The data were collected from primary and secondary sources. The primary data was collected through field visit on the selected highway segment in order to identify the deteriorated places and condition of drainage system; Road condition survey has carried out to determine the present state and condition of the selected study road sections. All the primary data were collected from the area having different weather conditions through the route of the road. while the secondary data collected were, standards used during the construction of the road, weather records from metrology agency and the design of the road previously used for the construction of the road. Both field observation and laboratory works for extracted sample were used before analysis. Some part of data collection is shown in figure 2 and figure 3.

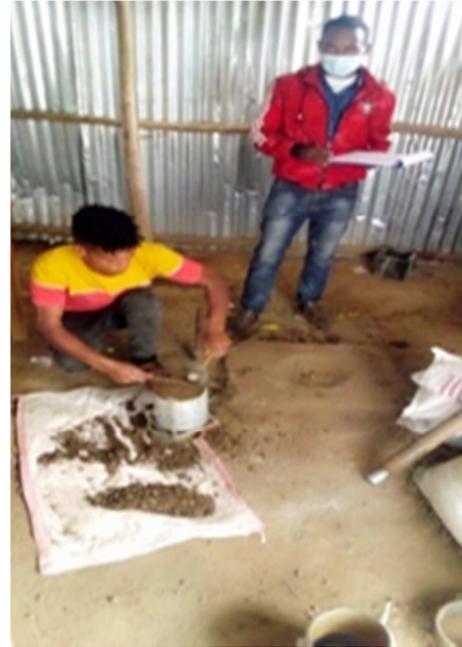
Figure 3. Sample extraction and preparation (photo: by Mengistu Bayu, 11th Jun, 2021).

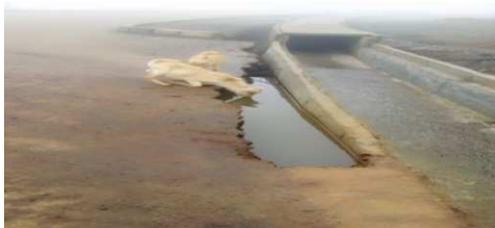
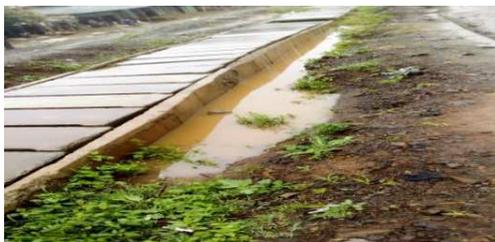
**Figure 8.** Ponding sides of U-ditch at Gessa Town (photo: by Mengistu Bayu, 19<sup>th</sup> May, 2021).

From field observation made, along the selected highway segment for this study, there is no effective side drainage constructed. Even though the road has been constructed five

years ago, the construction of side drain is not completed. In other hand, the drainage structures constructed are also not effective in removing the excess water from the pavement structure. In addition to this, as observed from field, in some places the constructed drainage structure is not properly managed and the construction procedure is not scientifically followed, see Figure 8: the backfilling work not done, due to this the surface water is directly enter to the pavement structure easily. This is abundant in Gessa town after construction of the pavement and U- ditch last three year.

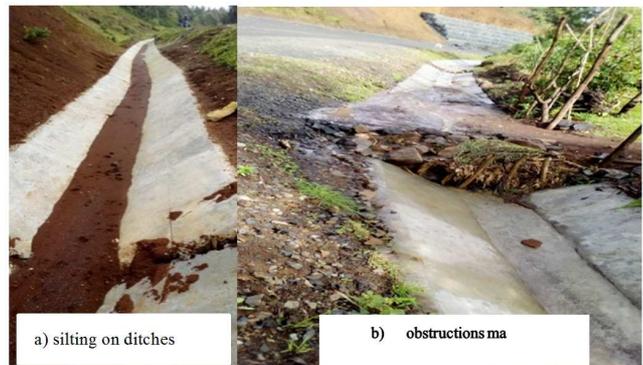
Meantime, it was observed defects on drainage structures on the selected road: obstructions, silting, ponding in drains and on shoulders, drain lining is damaged, defect at drain outfall, silting or debris blocking on culverts, erosion of culvert bed at outlet, minor headwall damage. The condition of silting and obstruction is shown in figure 9.

**Figure 9.** Different Obstructions on side ditch (photo: by Mengistu Bayu, 21<sup>th</sup> May, 2021).

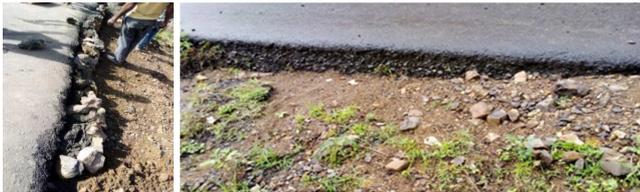
These are deformation, pumping, pothole and washing of the road pavement. The deformation observed was about 10 to 18 cm in all sampled places. Washing of the pavement shoulder also observed due to improper slope provided and this caused the edge break on different stations of the study segment. Figures 10 and 11 shows different damages occurred to roads in the study area as it was observed in the field investigation.

**Figure 10.** Observed problems on shoulder (photo: by Abebe Bura, 24<sup>th</sup> May, 2021).

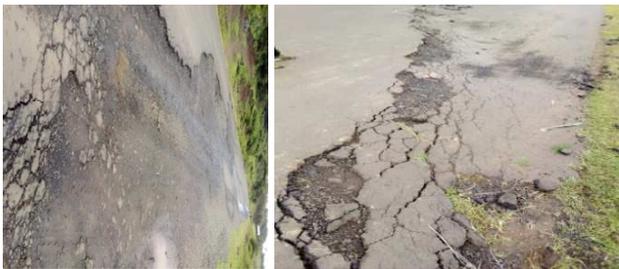
Generally different types of damages on the selected highway segment have observed during the study could be due to inadequacy of side ditches in removing water from the surface of pavement from surroundings.

**Figure 11.** Distresses on selected segment (photo: by Mengistu Bayu, 28<sup>th</sup> May, 2021).
